Technical Report 2

**FIELD EVALUATION OF SIX PROTECTIVE COATINGS APPLIED TO T-56
TUBINE BLADES AFTER 2000 HOURS OF ENGINE USE**

S.G. RUSSO

NOVEMBER 1992

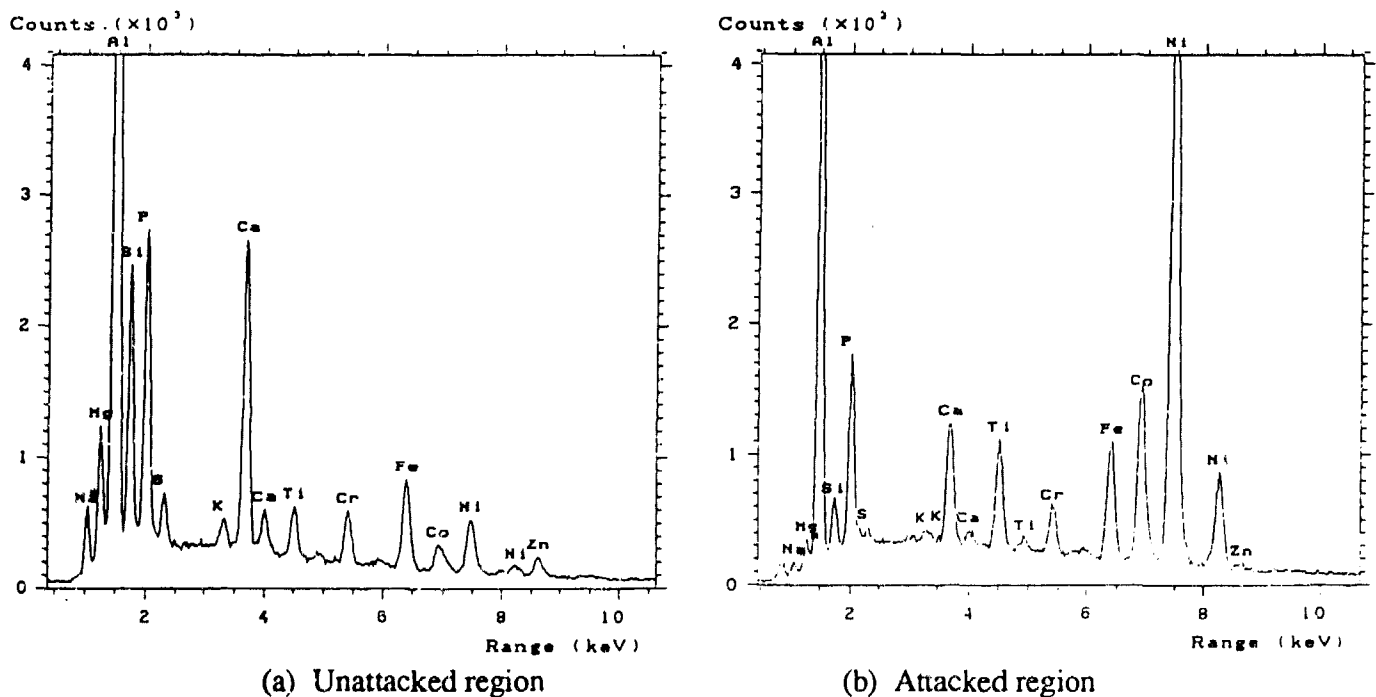
- ❑ several blade surfaces exhibited areas of blistering resulting in the formation of 'craters'. X-Ray analyses of these areas indicated higher concentrations of phosphorous, sodium and silicon and to a lesser extent calcium, than would otherwise be expected. It must also be noted that the surface of these blistered regions did not contain any sulfur.

- ❑ the quantity of sodium present in any region appeared to be directly related to the corresponding amount of magnesium present. The degree to which these elements were present was greater in the unattacked regions than in the regions of corrosive attack.

Figure 8 Typical X-Ray spectra of (a) an unattacked and (b) an attacked region from one of the sample turbine blades.
